**PENNSYLVANIA
ID NO. PA.00608**

PENN FOREST DAM

**PHASE I INSPECTION REPORT
NATIONAL DAM INSPECTION PROGRAM**

JUNE 1978

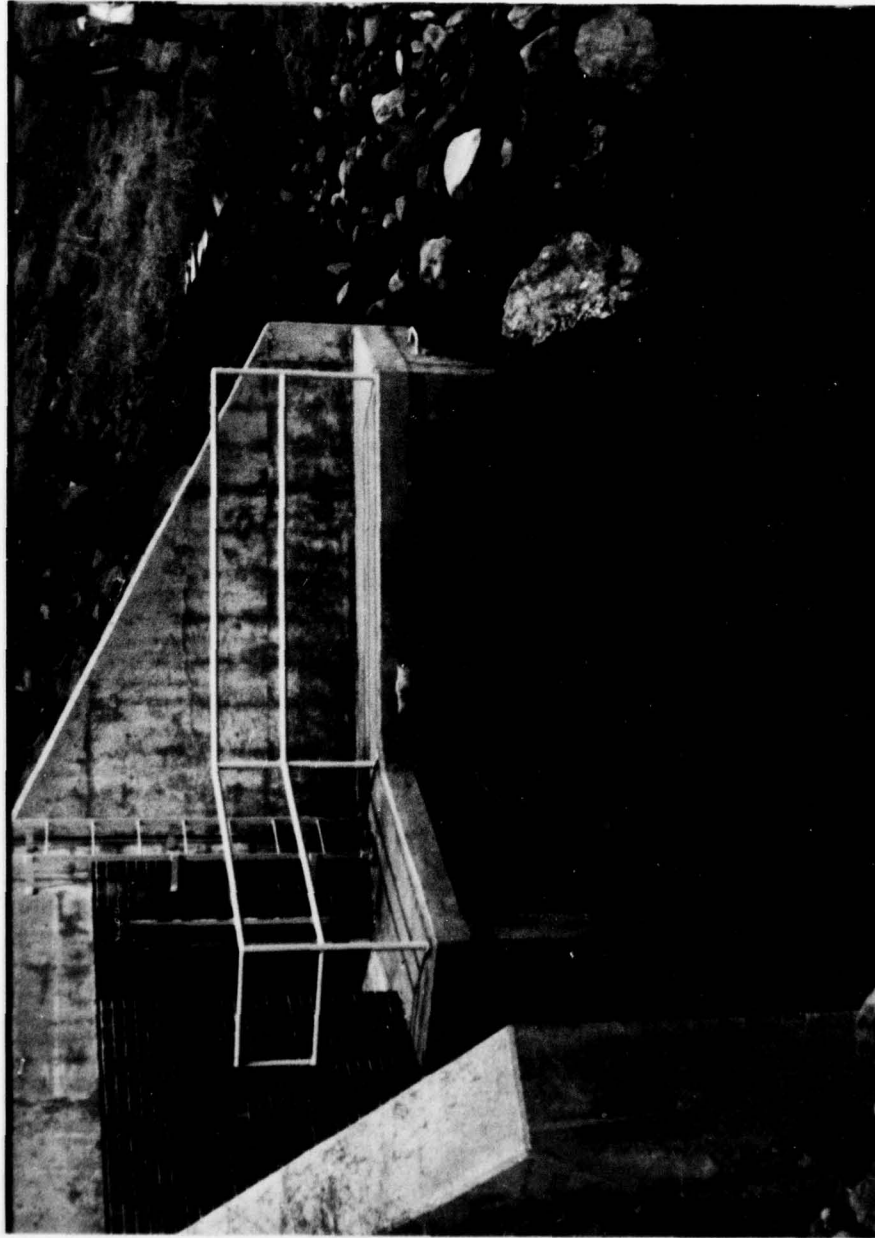
DRAWDOWN DISCHARGE STRUCTURE WITH 36-INCH OUTLET PIPE
(See Photo No. 2 for orientation).

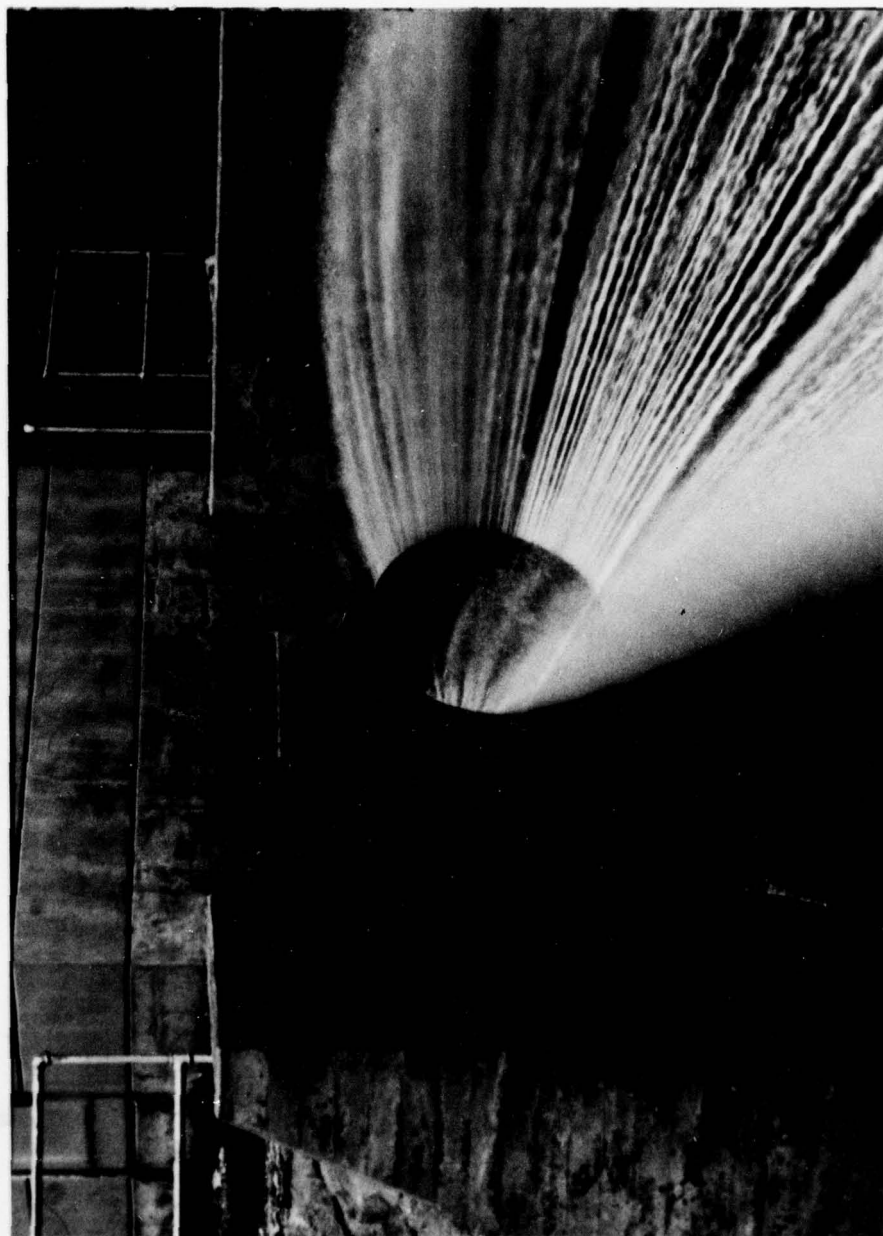
PHOTO NO. 4

The outlet structure enclosing the 48-inch Howell-Bunger valve appeared to be in generally good condition. The valve was exercised and all controls appeared to be operational.

OPERATING DISCHARGE STRUCTURE WITH 48-INCH SPRAY VALVE.
(See Photo No. 2 for orientation).

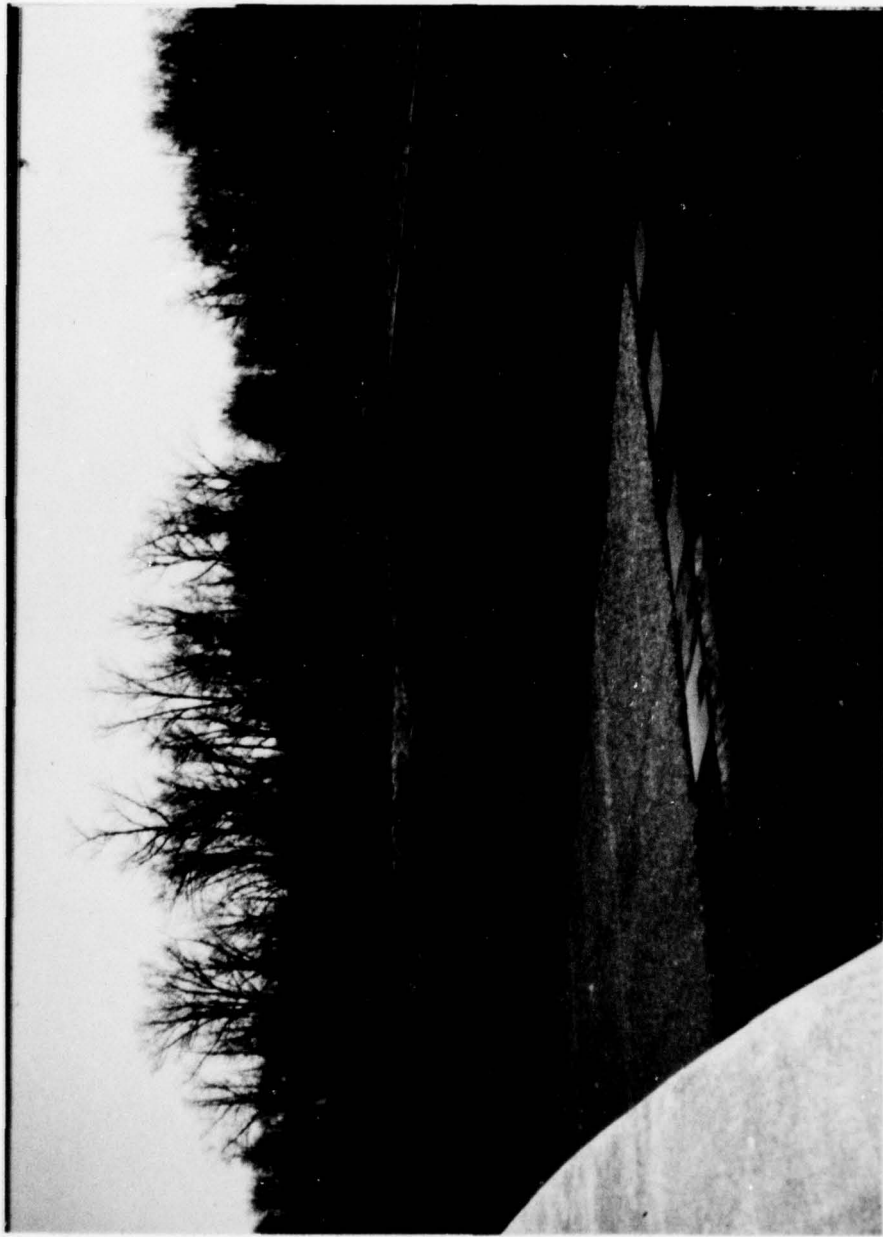
PHOTO NO. 5

c. Appurtenant Structures. At the time of the inspection, not more than one inch of water was flowing over the spillway. This spillway flow was observed to be reasonably smooth and uniform over the crest and down the spillway channel. Some minor concrete spalling was observed at occasional joints in the floor slab of the spillway and in the spillway walls. The spillway walls were observed to be in a straight line and showed no evidence of displacement or rotation. Throughout the spillway structure, minor shrinkage cracks were observed together with occasional scaling, pop-outs, and erosion of concrete. It was noted that concrete deterioration and occurrence of cracking appeared to be more severe around the stilling basin where calcium carbonate precipitate was also observed.

VIEW OF SPILLWAY CREST LOOKING DOWNSTREAM

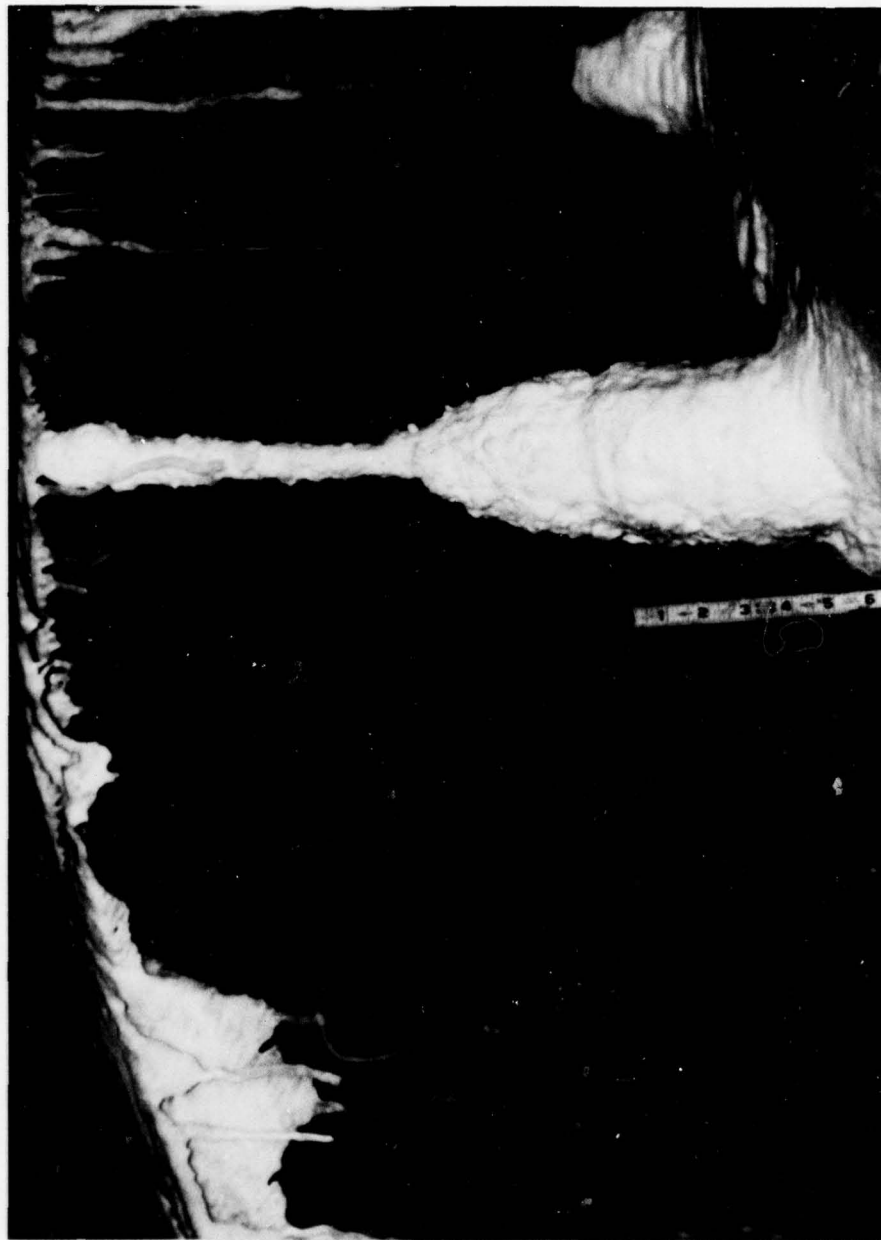
PHOTO NO. 10

The water discharge tunnel appeared to be in reasonably good condition. The floor of this tunnel is uncracked and at several locations the concrete arch was undercut for a distance of about 4 inches at the floor level. There are frequent transverse cracks, some of which appear to be construction joints, together with longitudinal cracks at the crown of the tunnel. These cracks were frequently denoted by calcium carbonate stalactites together with occasional staining of the concrete. Frequent leakage was observed in the tunnel that varied in quantity from barely perceptible seepage to a constant stream of water. In general, the frequency of cracking and seepage is greater upstream of the dam centerline. Occasional pipe supports in the tunnel exhibited local concrete deterioration.

CALCIUM CARBONATE PRECIPITATE FORMATION OVER 54-INCH
CONCRETE INTAKE PIPE IN INTAKE TUNNEL. NOTE PRECIPITATE
ACCUMULATION ALONG CRACK IN TUNNEL ROOF.
